The Kona Earthquake of August 21, 1951, and Its Aftershocks¹

GORDON A. MACDONALD and CHESTER K. WENTWORTH²

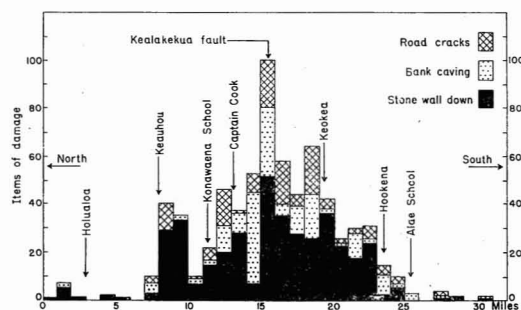
FIG. 3. Diagram showing the frequency distribution of three of the principal types of earthquake damage along the main highway. The arrows indicate the position on the highway of some villages and other features. Note the centering of damage close to the Kealahou fault.

The distribution of abundance of rock slides in road cuts is shown in Figure 3, in which it is represented by the portion of the columns labeled "bank caving." Like the other damage shown in the graph, it was greatest in the immediate vicinity of the Kealahou fault, inland from and a little south of Kealahou Bay.

of the epicenter can be derived from the study of damage by the earthquake. The general distribution of damage to roads, stone walls, and road cuts along the main highway is shown in Figure 3. This is based on a count checked against odometer mileage, assigning one unit of damage for each 1 to 15 feet of collapsed wall or road cut. Despite irregularities, the graph shows a distinctly symmetrical, bell-shaped distribution curve, with its peak about 2.5 miles by road southeast of Captain Cook. An average of more than 60 items of damage per mile in the central 5 miles decreases to only one or two per mile more than 9 miles from the center. This point of maximum damage coincides closely with the position of the buried inland extension of the Kealakekua fault. Other types of damage also were most abundant in the same general area. Together with the fact that most of the aftershocks, located by instrumental means, originated on the Kealakekua fault, it leaves little question that the origin of the major earthquake lay on or close to this fault, and that the earthquake almost certainly resulted from movement on it.

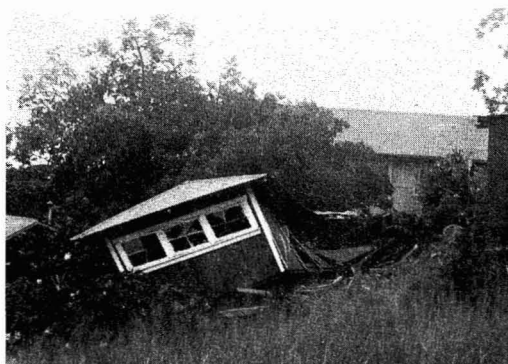
At Kaimalino, 0.3 mile south of Kealia (Fig. 1), a shop building collapsed. This building was placed on timber supports level with the highway in front but 6 feet above ground level in back, without adequate cross bracing.

FIG. 4. Overthrown shop building at Kaimalino, from the south.

Failure of the underpinning allowed the building to tilt backward and slump to the ground (Fig. 4). A similar situation was found at Keokea, 1.2 miles north of Kealia, where a service station building slumped downhill away from the highway and partly collapsed.

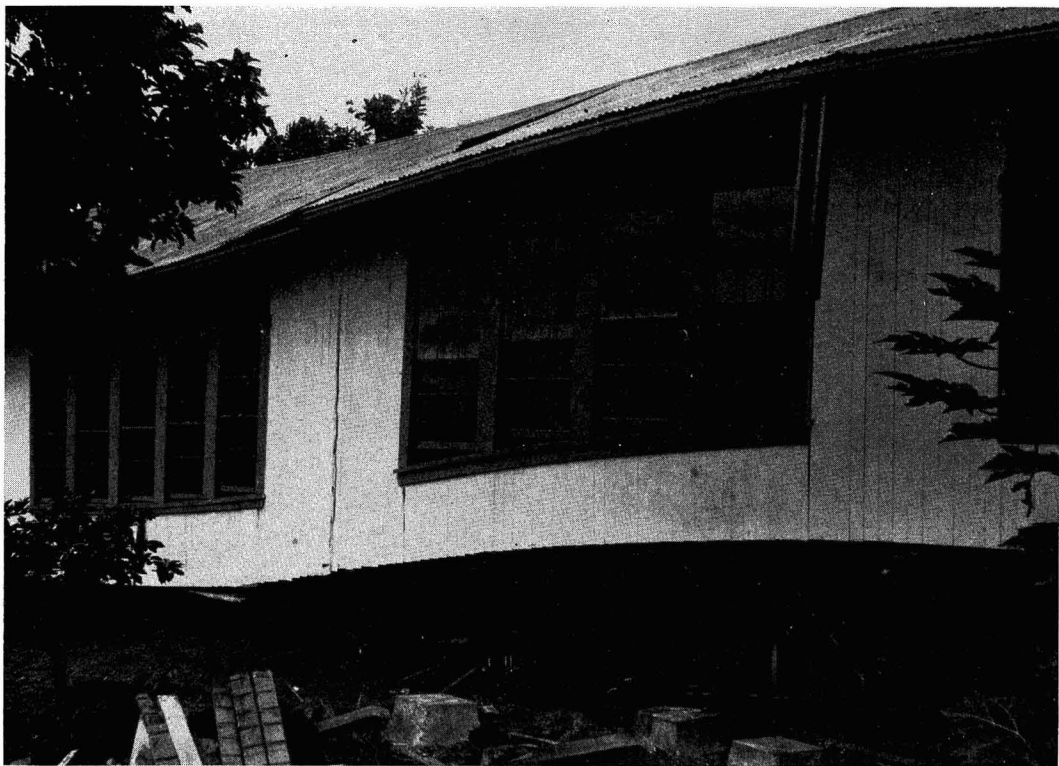
FIG. 5. Central portion of Honaunau School, from the southwest. All but the south end of this building was let down and moved westward owing to inadequate bracing of the underpinning in an east-west direction transverse to the longer dimension of the building.

structure, and the swaying of the structure caused the underpinning to fail in part and to allow the building to slump downhill onto the ground (Fig. 5). The building is considered a total loss.

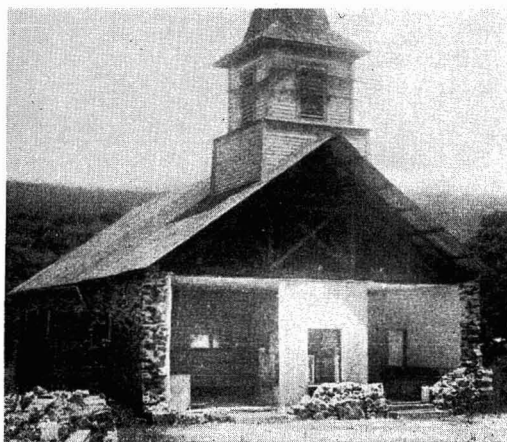
The Protestant church at Hookena Beach was badly damaged. The building consisted of masonry walls and a sheet-iron roof, supported on heavy handhewn beams which in turn were supported by east-west beams resting in niches on the upper edge of the front and back walls. During the earthquake nearly the whole front (west) wall was thrown out, some debris being as much as 25 feet from

FIG. 6. West end of Pukaana Church at Hookena Beach showing complete demolition of masonry wall of this 100-year-old structure. Much of the debris was cleared away soon after the earthquake. No nearly comparable damage to this building is known to have taken place during the century since it was built.

the building (Fig. 6). The other walls were not appreciably damaged, even the interior plaster being almost uncracked. It appears possible that during the quake the roof may have tended to move as a separate unit from the rest of the structure and, by its tendency to lag behind during the initial violent eastward movement of the ground, may have pushed out the front wall.

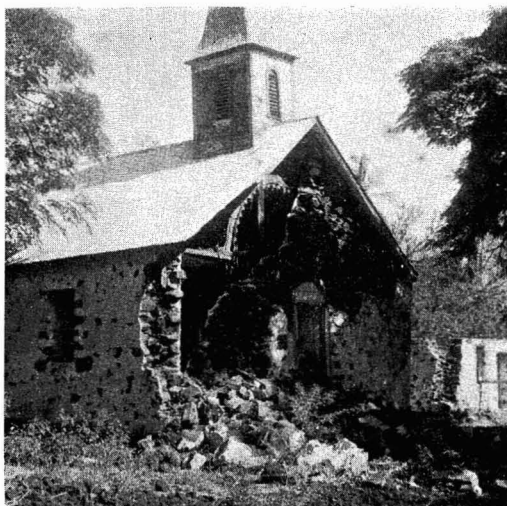
FIG. 7. Catholic Church 0.6 mile north of Hookena Beach, from the northwest. The east end of this church was similarly thrown down and outward, to the east. The near corner and the corresponding corner of the small building, already without a roof, suggest displacement most markedly to the northwest, in the general direction of the epicenter.

The Catholic church 0.6 mile north of Hookena Beach was very heavily damaged. The upper portions of both the east and west walls were thrown down (Fig. 7), and the interior plaster on all walls was badly cracked. However, the walls were built merely of loose stones laid together without mortar between them except close to the faces, where the interior and exterior plaster had penetrated a short distance. Considering the type of

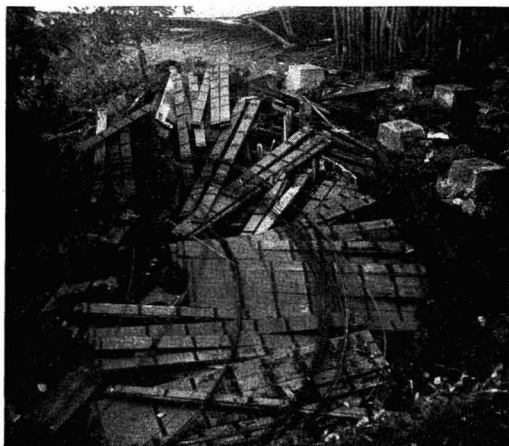
Altogether, approximately 200 tanks of a total of more than 1,000 in the heavily shaken area were damaged or destroyed by the earthquake. Tank damage extended from Keauhou on the north to Milolii on the south and was most severe in the area from Captain Cook to Hookena. Tanks showed all degrees of failure, from the development of slight leaks to complete collapse. A few tanks may, at least in part, have been pushed over by neighboring structures. Thus, the tank at the southern end of the Honaunau School building (Fig. 8) may have been partly pushed westward by the collapse of the adjacent

FIG. 8. Demolished tank west of the south end of Honaunau School, footings on which the tank formerly stood, and part of the school building, from the south-west.

building, to which it was connected by a rigid wooden down-spout. However, most of the damaged tanks appear to have failed because of their own behavior during the earthquake. The commonest features contributing to tank failure appear to have been poor footings and inadequate cross bracing of the underpinning.

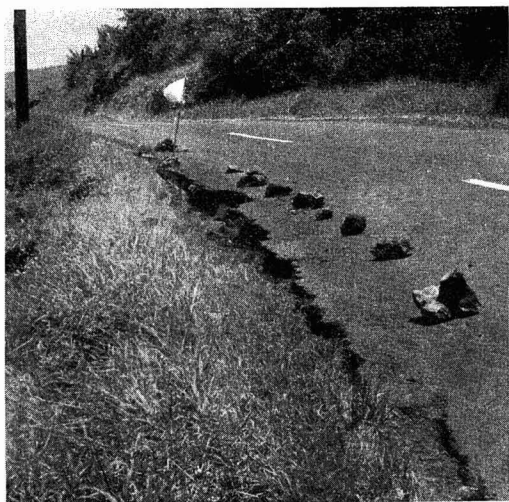
FIG. 9. Crack along roadside south of Kealakekua, from the south, showing separation of embankment from edge of pavement due to slumping.

slope face of the fill was dislodged, allowing the material of the road bed to settle, cracking the pavement. In other places the fill appears to have settled a little merely by compaction during the jostling by the earthquake, causing cracks in the pavement.

A common occurrence was the formation of a crack parallel to the edge of the pavement on its downslope side, either within the pavement a few inches from its edge or between it and the shoulder (Fig. 9). Some of these were as much as 75 feet long and 8 inches wide. This appears to have resulted from a downslope lurching of the shoulder, moving as a separate unit from the portion of the fill beneath the pavement. The independence of movement of the shoulder and pavement was interestingly shown along the highway about 2 miles southeast of Captain Cook, where soil and sod on the shoulder were overthrust as much as an inch onto the pavement.

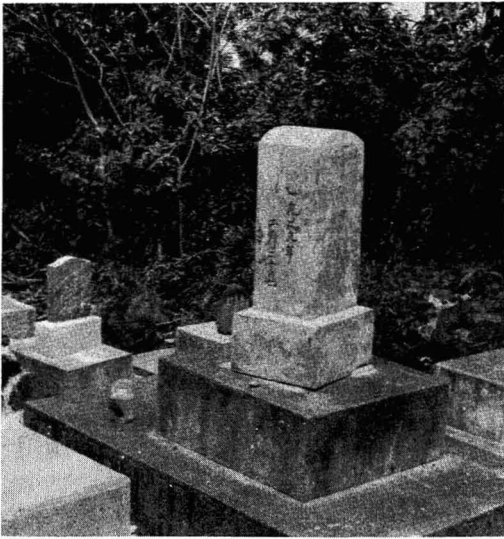
FIG. 10. Gravestone rotated counterclockwise, in Daifukuji cemetery, Kainaliu, looking approximately northwest.

north of Napoopoo, of an estimated total of 150 grave markers, 6 toppled west, 7 north, 2 east, and none south. Six had been shifted north, 16 were twisted counterclockwise, and 2 clockwise; 8 grave caps were broken (Fig. 10). It was reported that many more had been disturbed but had been restored.

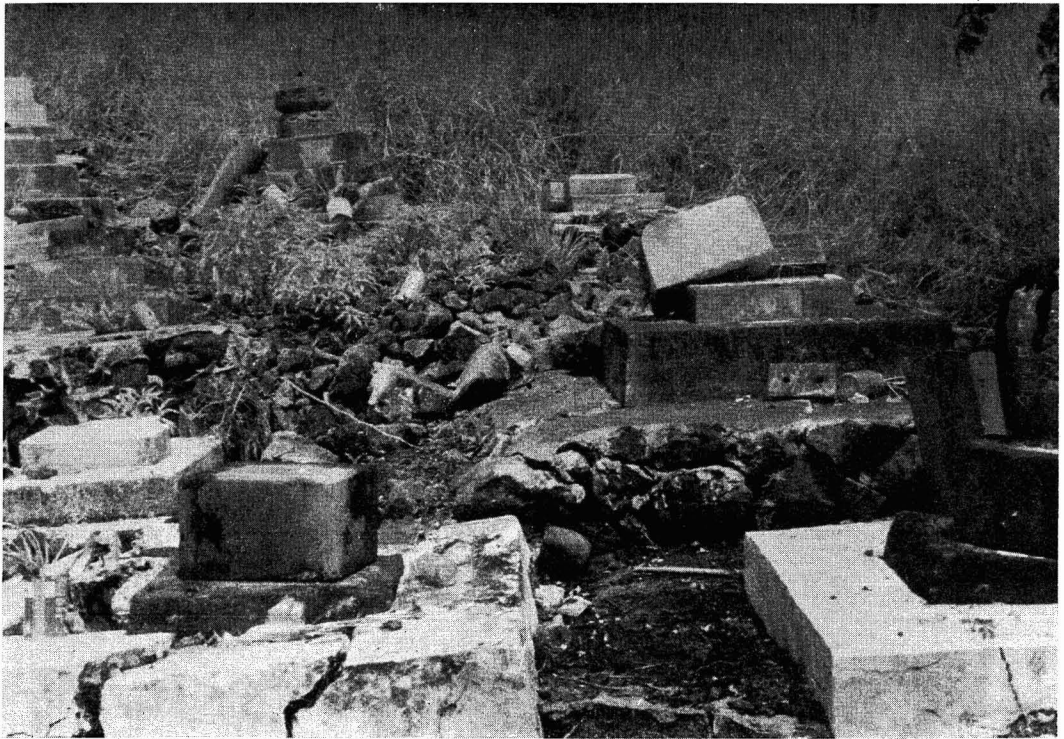
The most complete derangement of gravestones was found in the Kalahiki Japanese cemetery, a small hillside cemetery 3.8 miles south of Kealia, where only 2 of 30 markers were found in position 5 days after the earthquake (Fig. 11). The dislodgement was chiefly to the southwest and, to a lesser extent, to the northeast. Ten were shifted to the north without being thrown down. Seven, including some of these 10, were rotated clockwise and one counterclockwise. Here, on loose, steeply sloping ground, a large proportion of the grave caps were broken, owing to poor design and to construction on the newly heaped grave mound. This cemetery is about 11 miles south of the probable epicenter. South of this point no cemeteries with headstones susceptible to overturning or rotation were found.

FIG. 11. Broken bases, displaced base stones, and overturned headstones in Kalahiki Japanese cemetery, south of Kealia, looking southeast. Partly because of unstable hillside ground and partly because of proximity to the epicenter, damage in this cemetery was widespread and severe; scarcely a grave escaped marked derangement.

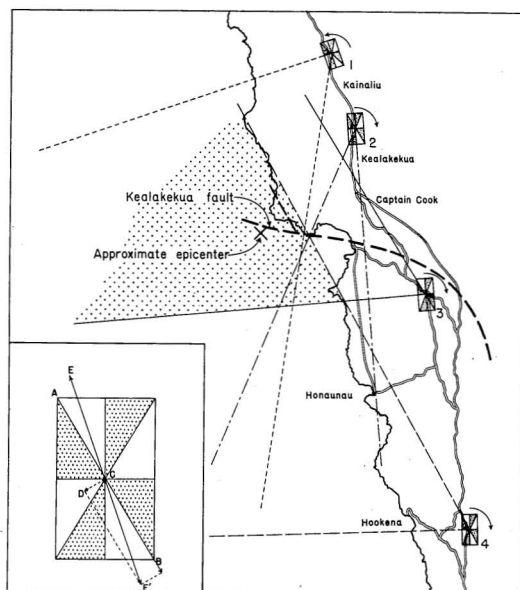
Imamura (1937: 96) has shown that the direction of rotation of short rectangular columns, such as many headstones are, can be useful in determining the direction of motion during an earthquake and, consequently, the approximate azimuth of the line toward the epicenter. If the earthquake motion is parallel to the sides or to the diagonal (A—B, inset, Fig. 12) of the column, rotation probably will not occur. However, if the earthquake motion is in some intermediate direction, such as E—E' in Figure 12, a rocking of the column will be accompanied by a rotational tendency. A ground motion in the direction E' will cause the column to rock on the corner B. At the same time, the resultant of the force E' in the direction CD will tend to rotate the column about the corner B in a counterclockwise direction. Similarly, a motion in the direction E will tend to cause a counterclockwise rotation about corner A. Directions of earthquake motion lying in the unshaded octants of the diagram tend to cause counterclockwise rotation of the column, and directions of motion in the shaded octants tend to cause clockwise rotation.

FIG. 12. Map of the central Kona area, showing the prevalent direction of rotation of monuments in cemeteries. The cemeteries are: 1, Daifukuji, Honalo; 2, Hongwanji Mission, Kealakekua; 3, Hongwanji Mission, Kēē; 4, Kalahiki Japanese. At each cemetery the arrow indicates the prevalent direction of rotation. The boundaries of the octants containing the direction toward the epicenter are prolonged. The stippled area west of Captain Cook is that in which three or more of the octants overlap. The inset in the lower left is a diagram (after Imamura, 1937) of a horizontal cross section of a rectangular column, indicating the manner in which horizontal earthquake motion E—E' causes rotation of the column.
